# Manhole Inspection Summary

Manhole # S51M\_\_002MH

Insp Date: **4/14/08 11:41 AM**

**Location** Address: **2912 s linwood curely**

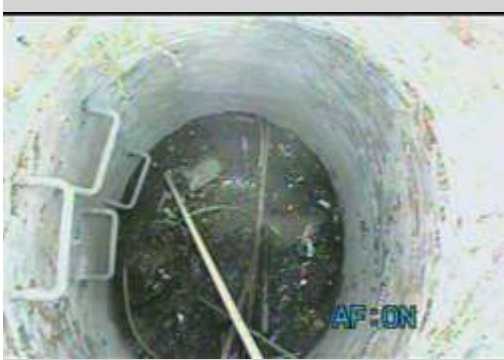
Defect 3

Condition: ☐ Sound ☐ Cracked ☐ Root Intrusion ☐ Deteriorated ☐ Leaks ☒ **Debris**

channel debris

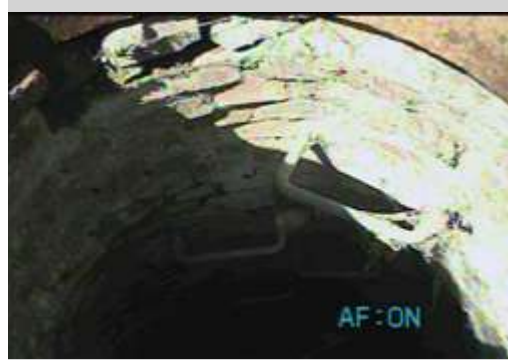
Defect 2

**Steps** Count: **5** Missing: **0** ☒ **Corroded**

corroded stairs

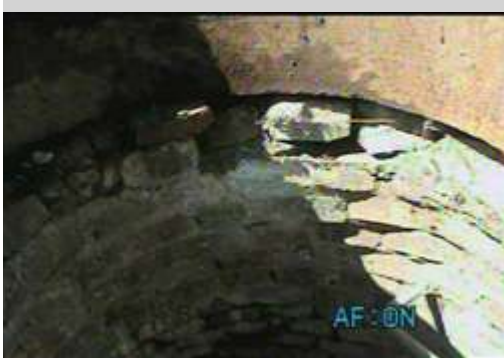
Defect 1

Condition: ☐ Sound ☒ **Cracked** ☐ Root Intrusion ☒ **Loose Brick** ☐ Deteriorated

loose brick and crack in frame adjustment
